**K-MARINE ENGINEERING PTE LTD**

**CUSTOMER ORDER REF. : 6089-90143****JOB RECORD**

| <b>CUSTOMER</b> | | <b>VESSEL</b> | M.V. "MAERSK SHEKOU" | <b>JOB NO.</b> | 2064 |
| <b>ITEM</b> | WATER BALLAST NO. 3 WING TANKS WEB FRAME DAMAGED PORTIONS X 3 LOCATIONS | <b>CLASS</b> | L.R.S. | <b>DATE</b> | 09/12/2024 |

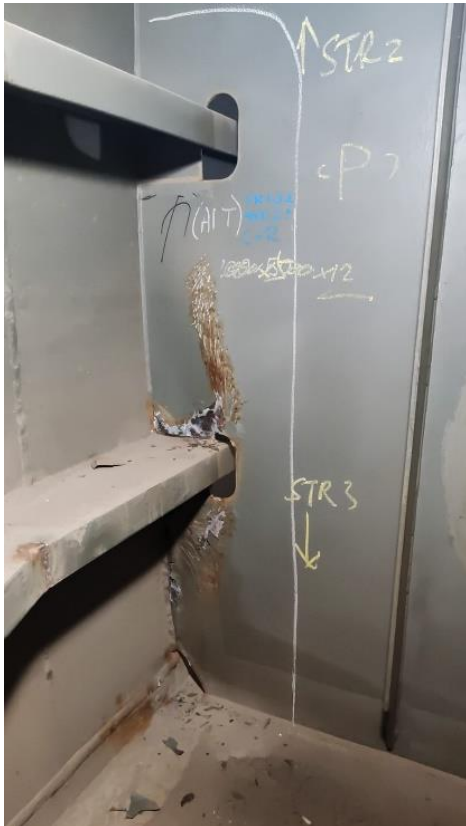
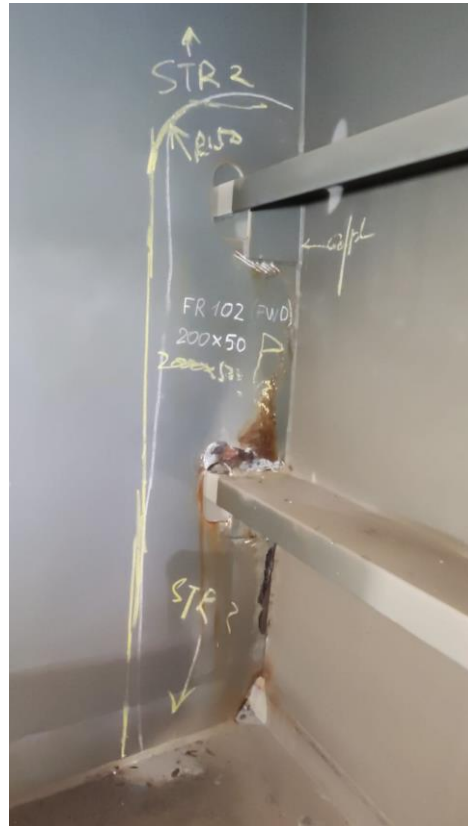
**WEB FRAME 102 (BETWEEN STR. NO. 2 & STR. NO. 3 I.W.O. SL-38 & SL-39)**

| <b>COMPONENT</b> | W.B.T. NO. 3 PORT WEB FRAME DAMAGED PORTION REPAIR BY<br>NEW STEEL INSERTION X 2 LOCATIONS | <b>STATUS</b> | WEB FRAME 102 & FRAME 104 DAMAGED PORTIONS<br>PRE-INSPECTION AT P.S.A. PASIR PANJANG TERMINAL | <b>DIMENSIONS</b> | N.A. |

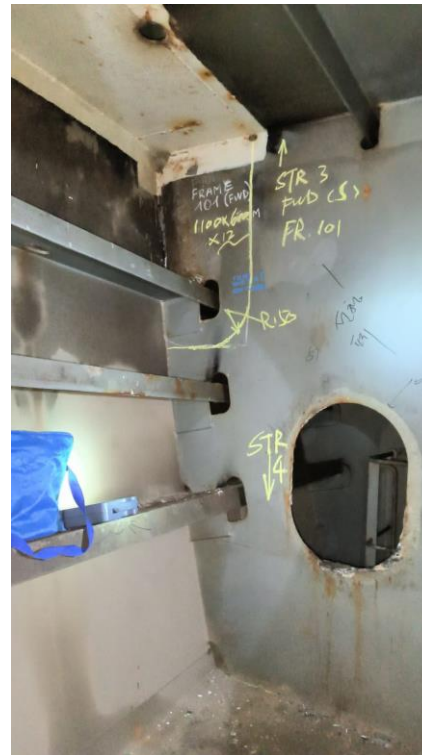
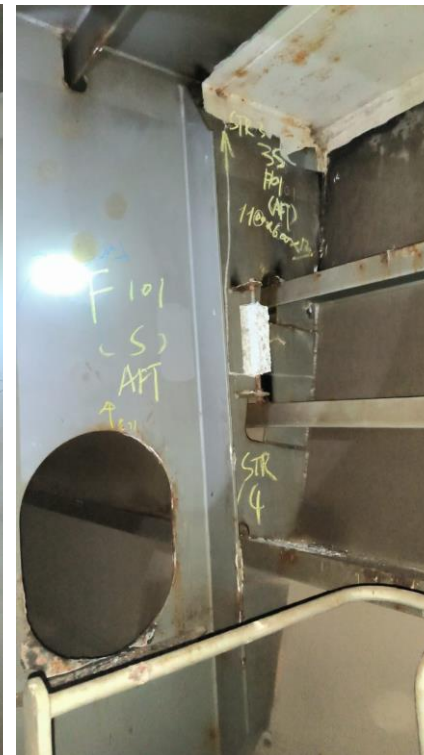
**WEB FRAME 101 (BETWEEN STR. NO. 3 & SL-35.1 I.W.O. SL-36)**

| <b>COMPONENT</b> | W.B.T. NO. 3 STBD WEB FRAME DAMAGED PORTION REPAIR BY NEW STEEL INSERTION X 1 LOCATION | <b>STATUS</b> | WEB FRAME 101 DAMAGED PORTION PRE-INSPECTION AT P.S.A. PASIR PANJANG TERMINAL | <b>DIMENSIONS</b> | N.A. |

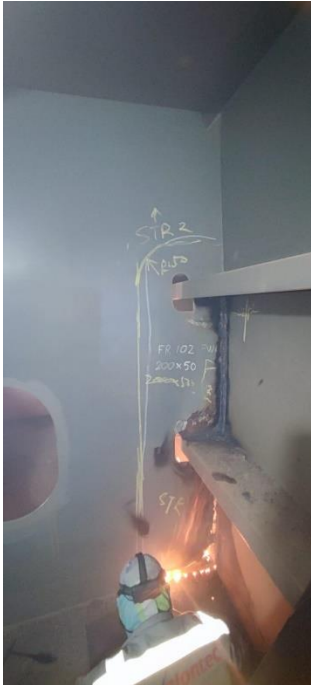
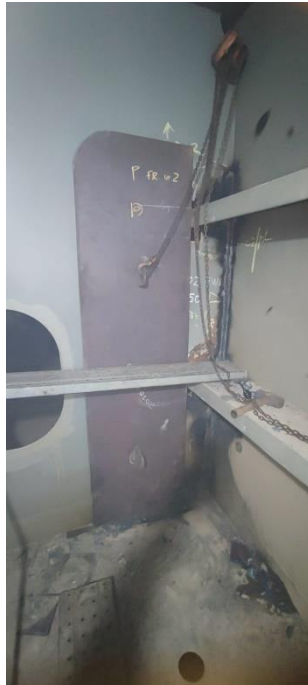
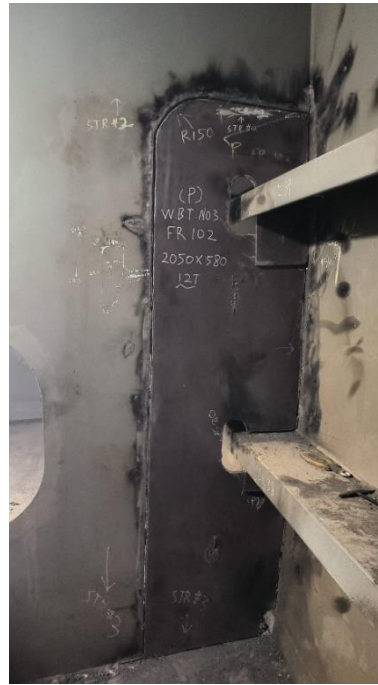
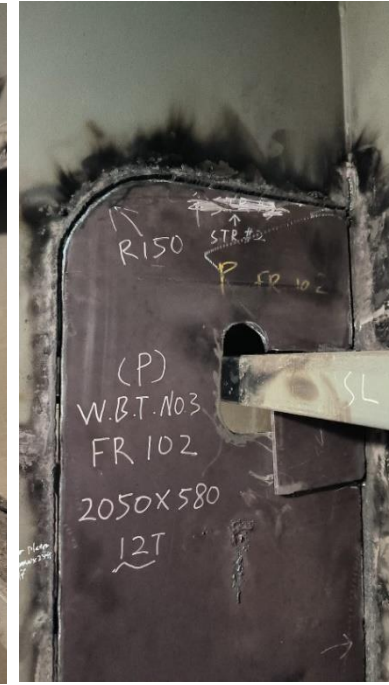
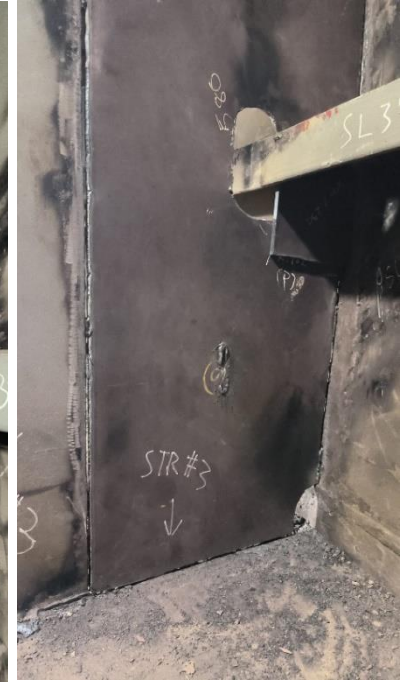
**NEW STEEL INSERTION IN PROGRESS**

**FIT-UP INSPECTION**

NOTE : HIGH TENSILE STEEL GRADE ABS/EH36 NEW PLATE INSERTION AT FRAME 102 - 12T X 580W X 2,050H X 1 CORNER 150R X 2 COLLAR PLATES (12T X 200W X 230H) X 1 OFF (BETWEEN STRINGER NO. 2 & STRINGER NO. 3 IN WAY OF SL-38 & SL-39).

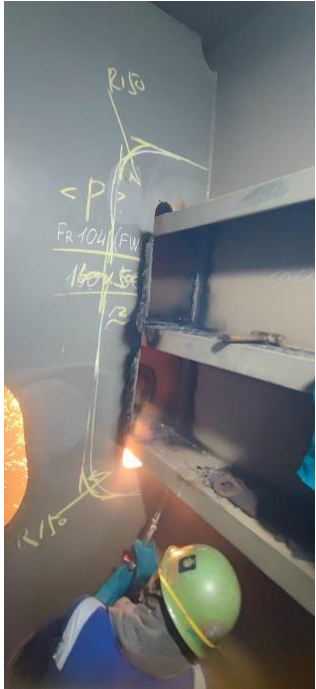
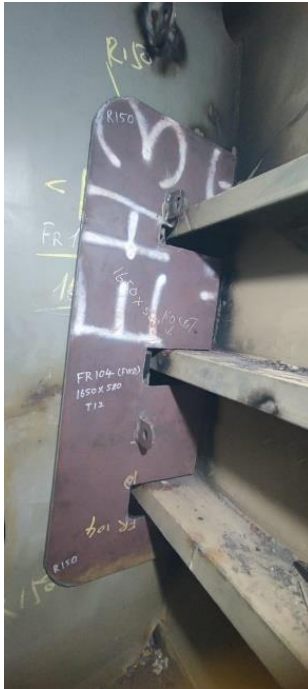
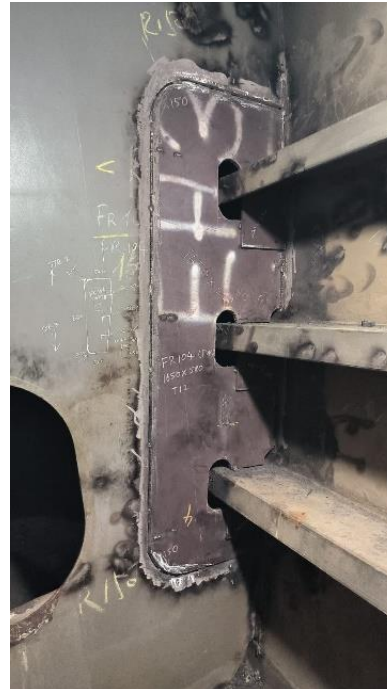
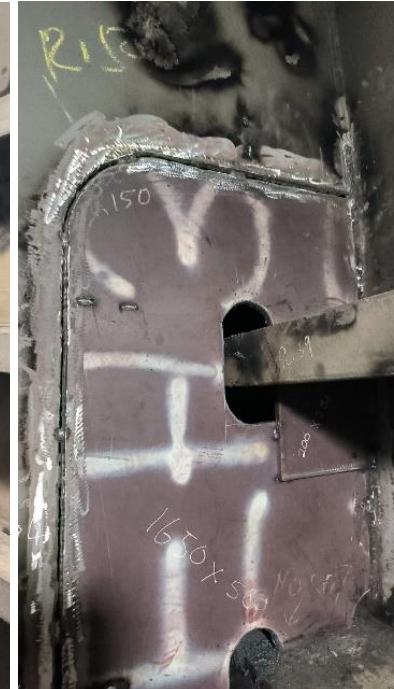
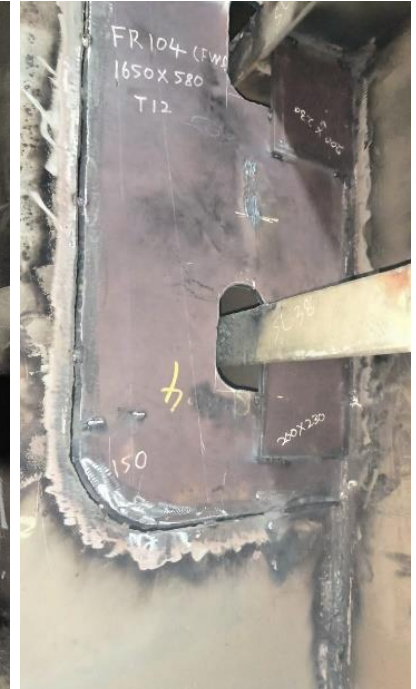
**NEW STEEL INSERTION IN PROGRESS****FIT-UP INSPECTION**

NOTE : HIGH TENSILE STEEL GRADE ABS/EH36 NEW PLATE INSERTION AT FRAME 104 - 12T X 540W X 1,650H X 2 CORNERS 150R X 3 COLLAR PLATES (12T X 200W X 230H) X 1 OFF (BETWEEN STRINGER NO. 2 & STRINGER NO. 3 IN WAY OF SL-38, SL-38.1 & SL-39).

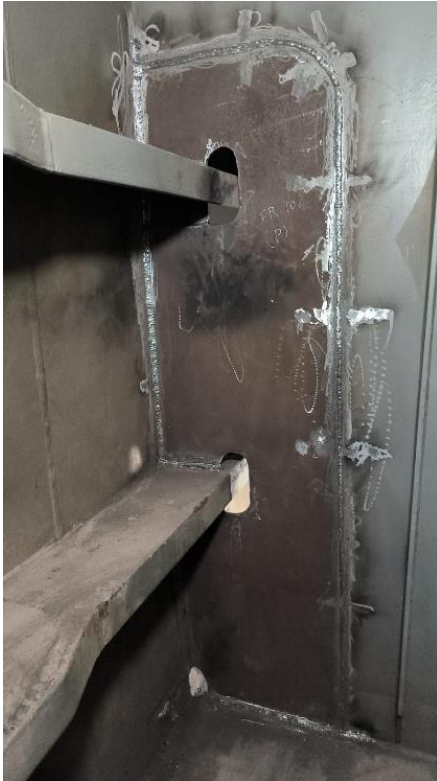
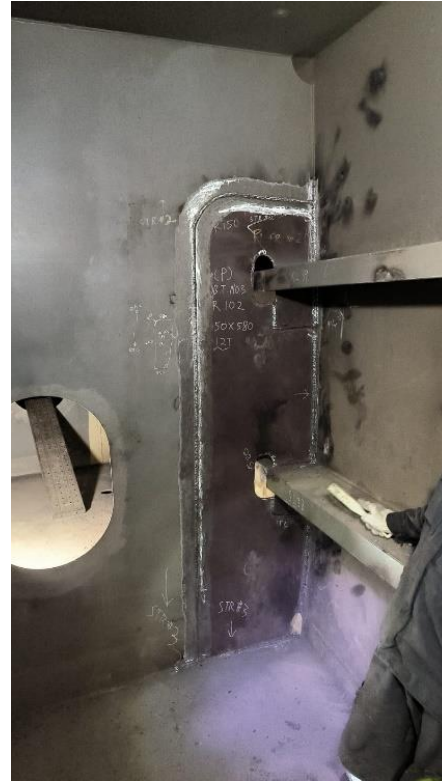
**WEB FRAME 102**

| <b>COMPONENT</b> | W.B.T. NO. 3 PORT WEB FRAME DAMAGED PORTION REPAIR BY<br>NEW STEEL INSERTION X 2 LOCATIONS | <b>STATUS</b> | WEB FRAME 102 & FRAME 104 NEW STEEL<br>INSERTIONS WELDMENTS INSPECTION | <b>DIMENSIONS</b> | N.A. |

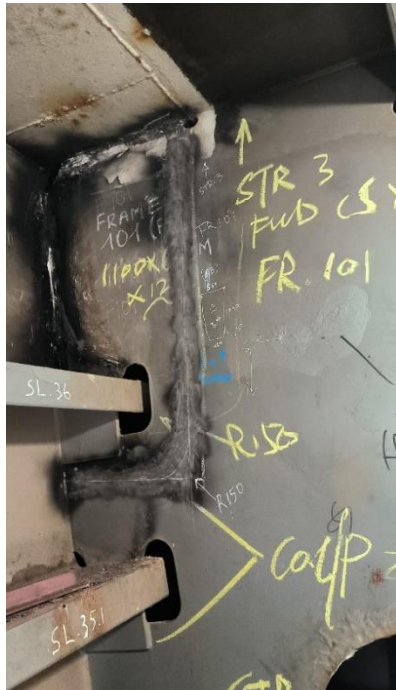
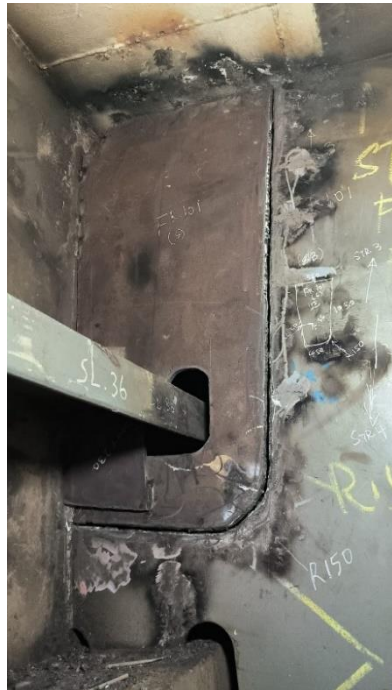
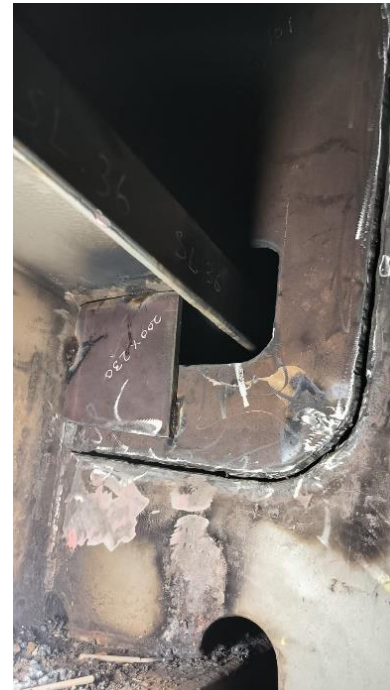
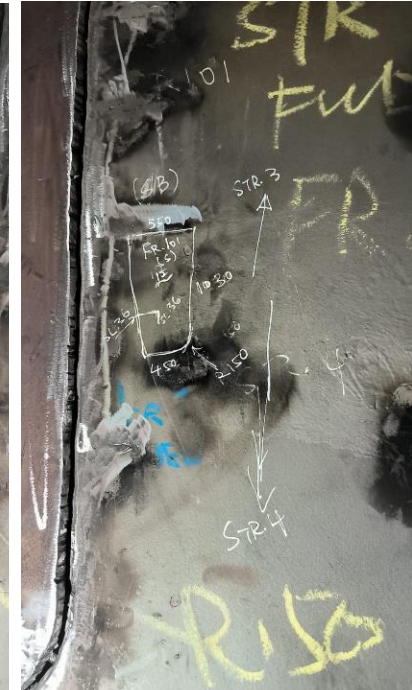
**NEW STEEL INSERTION IN PROGRESS**

**FIT-UP INSPECTION**

NOTE : HIGH TENSILE STEEL GRADE ABS/EH36 NEW PLATE INSERTION AT FRAME 101 - 12T X 550W X 1,030H X 1 CORNER 150R X 1 COLLAR PLATE (12T X 200W X 230H) X 1 OFF (BETWEEN STRINGER NO. 3 & SL-35.1 IN WAY OF SL-36).

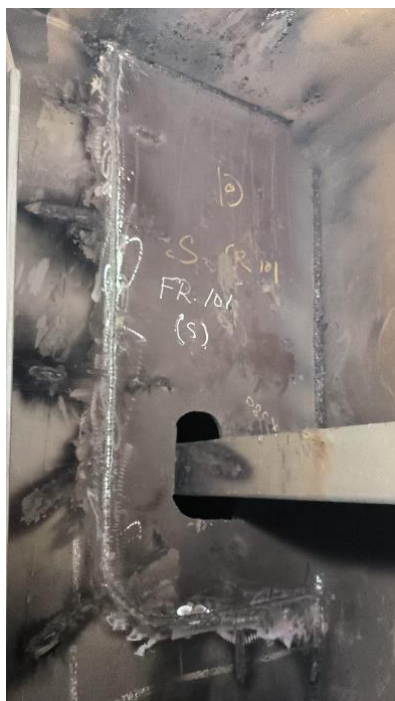
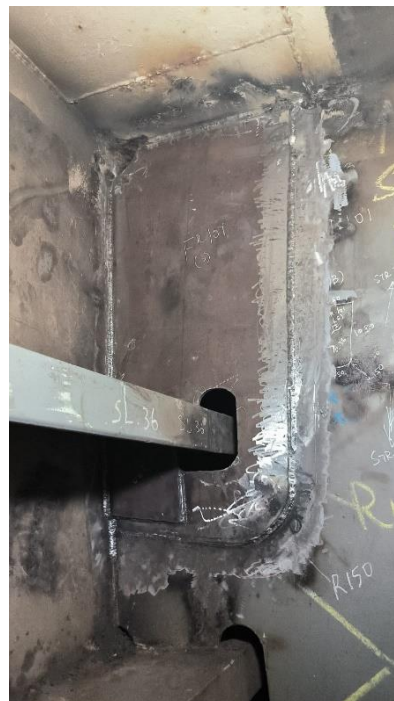
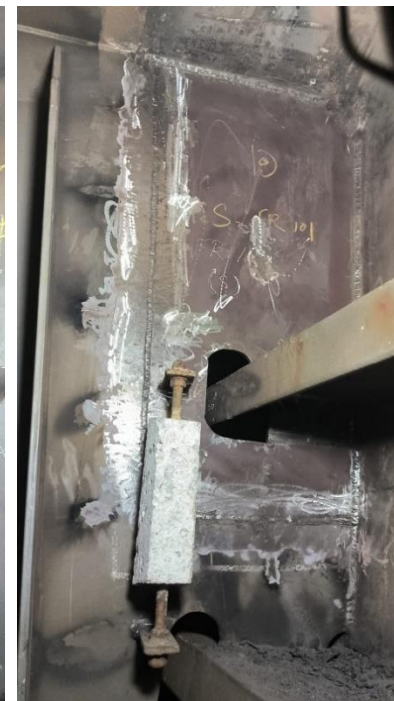
**BACK GOUGING INSPECTION**

**WELDMENTS INSPECTION**

NOTE : (1) WEB FRAME DAMAGED PORTION REPAIRED WITH NEW STEEL INSERTION BY FULLY WELDING UP FROM BOTH SIDES WITH THE NECESSARY BACK GOUGING IN GOOD ORDER.  
(2) ZINC ANODE (1 OFF) REMOVED & REINSTALLED FOR JOB ACCESS.

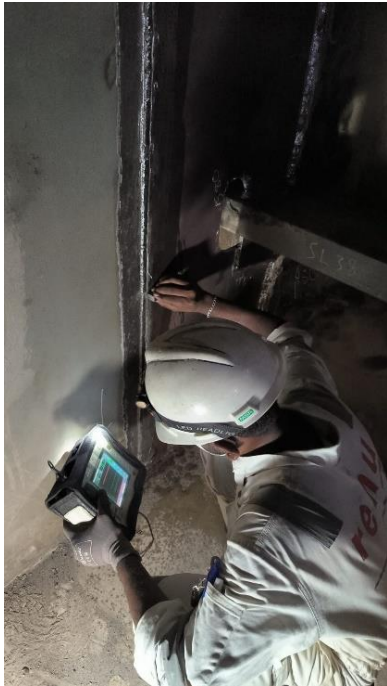
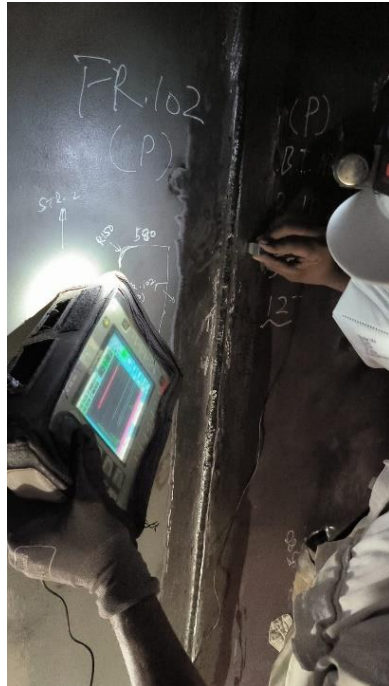
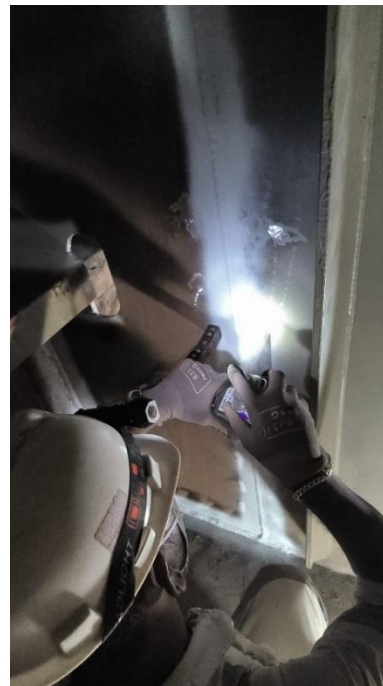
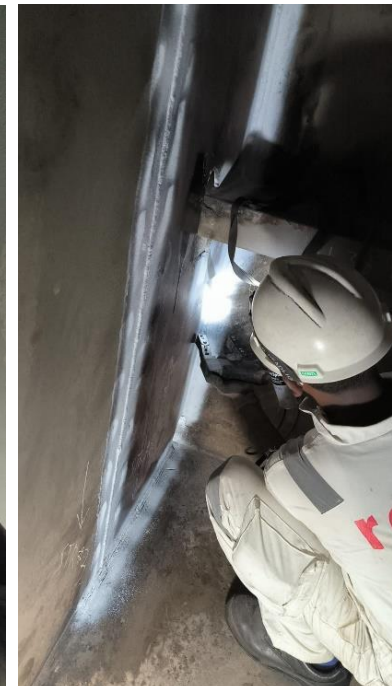
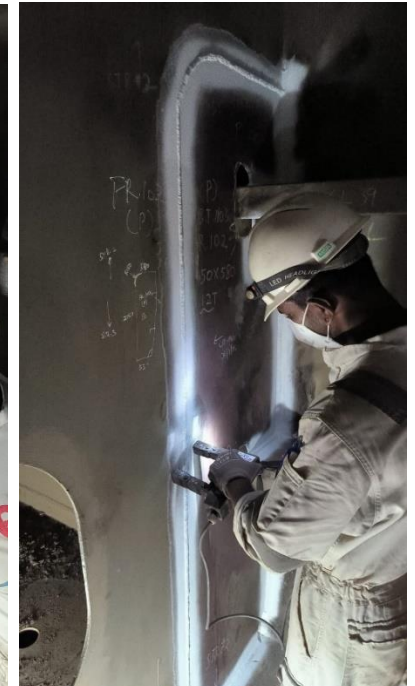
| <b>COMPONENT</b> | W.B.T. NO. 3 PORT WEB FRAME DAMAGED PORTION REPAIR BY NEW STEEL INSERTION X 2 LOCATIONS | <b>STATUS</b> | WEB FRAME 102 NON-DESTRUCTIVE TEST ON NEW WELDMENTS | <b>DIMENSIONS</b> | N.A. |

NOTE : THE WEB FRAME NEW STEEL INSERTION WELDMENTS PERFORMED MAGNETIC PARTICLES INSPECTION & ULTRASONIC FLAW DETECTION TEST UPON COMPLETION OF PRECEDING WORKS.

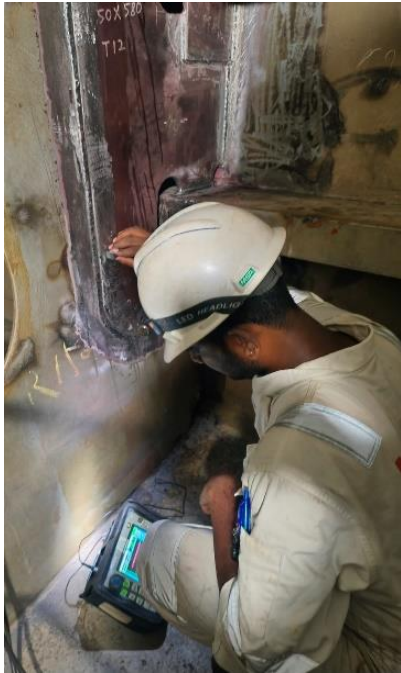
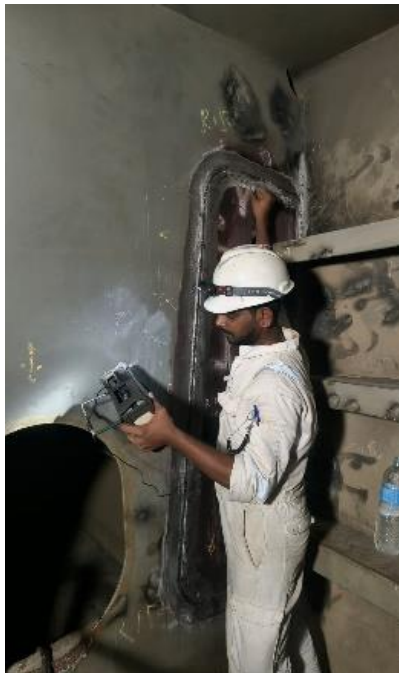
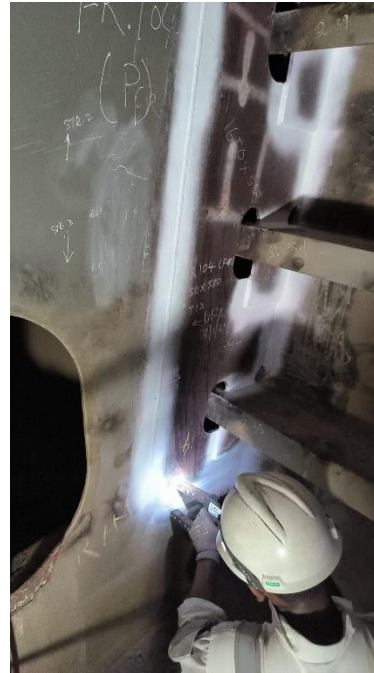
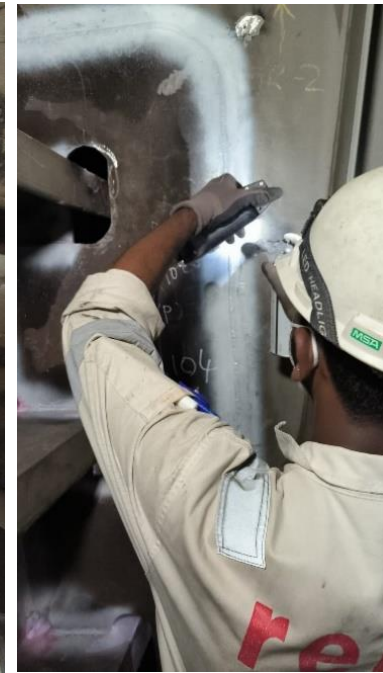
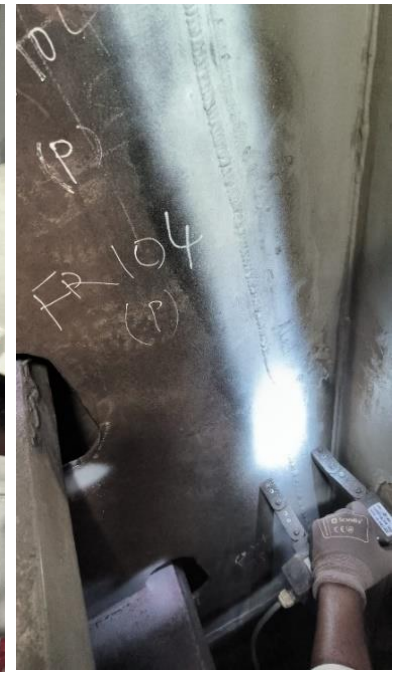
| <b>COMPONENT</b> | W.B.T. NO. 3 PORT WEB FRAME DAMAGED PORTION REPAIR BY NEW STEEL INSERTION X 2 LOCATIONS | <b>STATUS</b> | WEB FRAME 104 NON-DESTRUCTIVE TEST ON NEW WELDMENTS | <b>DIMENSIONS</b> | N.A. |

NOTE : THE WEB FRAME NEW STEEL INSERTION WELDMENTS PERFORMED MAGNATIC PARTICLES INSPECTION & ULTRASONIC FLAW DETECTION TEST UPON COMPLETION OF PRECEDING WORKS.

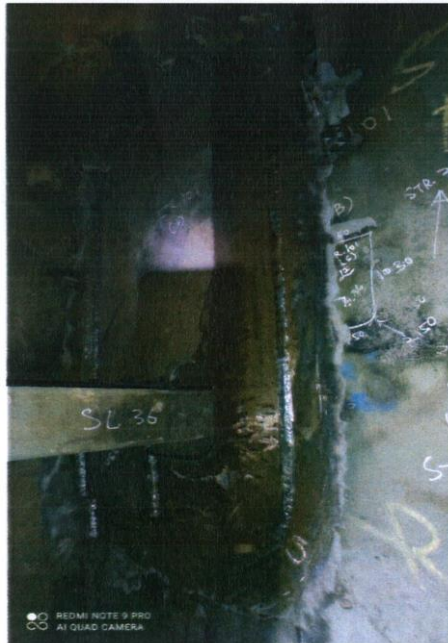
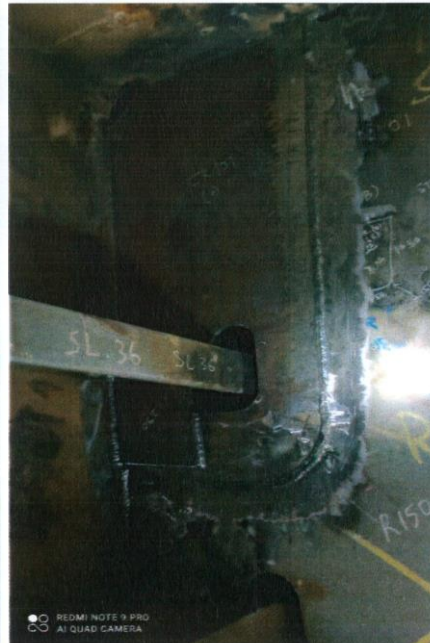
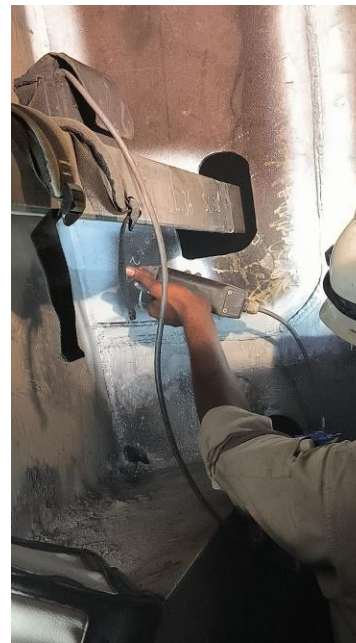
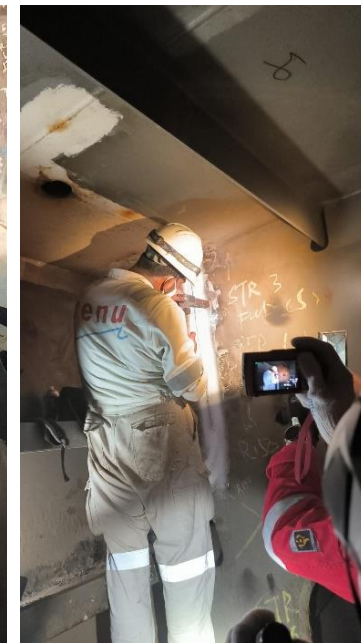
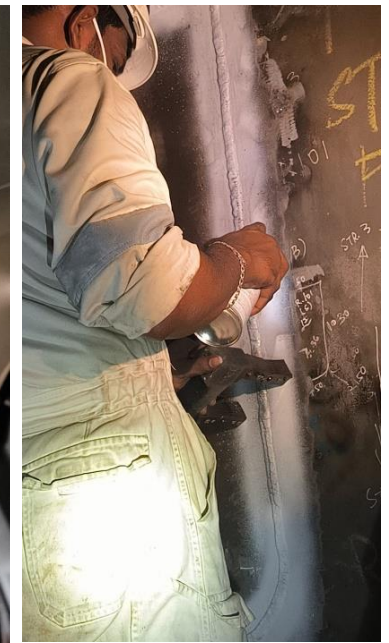
| <b>COMPONENT</b> | W.B.T. NO. 3 STBD WEB FRAME DAMAGED PORTION REPAIR BY NEW STEEL INSERTION X 1 LOCATION | <b>STATUS</b> | WEB FRAME 101 NON-DESTRUCTIVE TEST ON NEW WELDMENTS | <b>DIMENSIONS</b> | N.A. |

NOTE : THE WEB FRAME NEW STEEL INSERTION WELDMENTS PERFORMED MAGNATIC PARTICLES INSPECTION & ULTRASONIC FLAW DETECTION TEST UPON COMPLETION OF PRECEDING WORKS.
