**K-MARINE ENGINEERING PTE LTD**

**CUSTOMER ORDER REF. : P425-0007-6146-GAG****JOB RECORD**

| <b>ITEM</b> | CARGO OIL PUMP TURBINE NO. 3 | <b>CLASS</b> | A.B.S. | <b>DATE</b> | 15/06/2025 |
| <b>COMPONENT</b> | TURBINE INSPECTION & OVERHAULING WITH PINION ROTOR ASSEMBLY REPLACEMENT | <b>STATUS</b> | TURBINE PINION ROTOR INSPECTION AT DISASSEMBLY | <b>DIMENSIONS</b> | N.A |

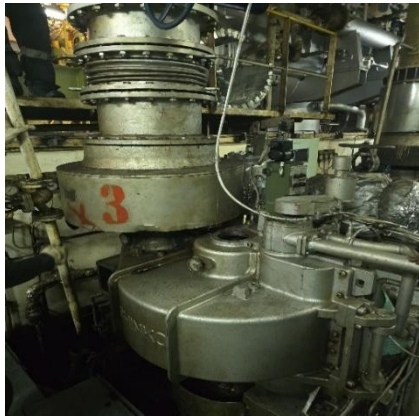
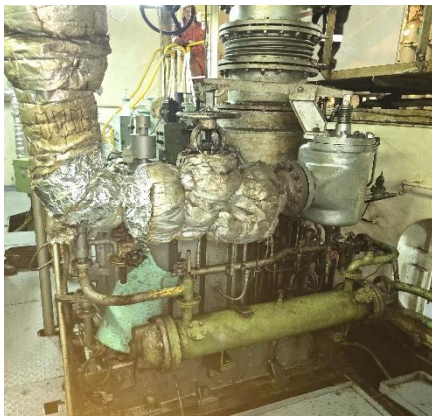
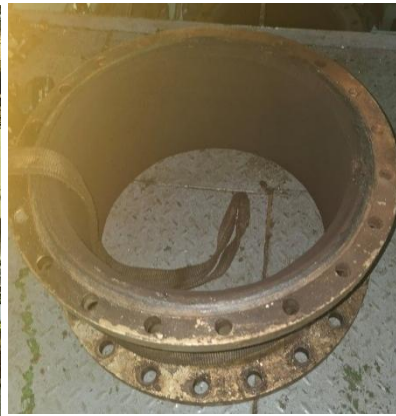
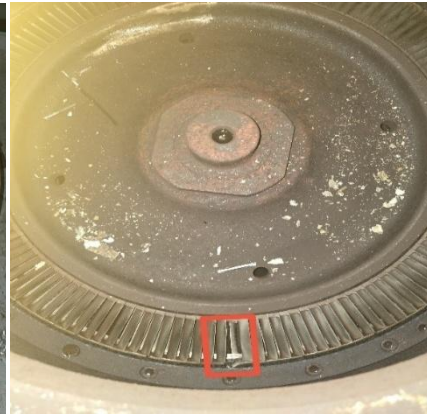
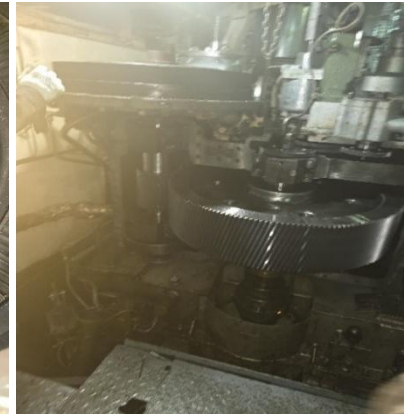
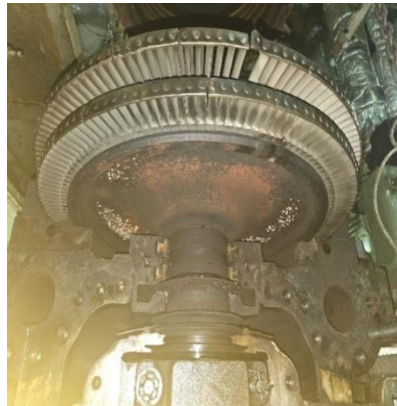
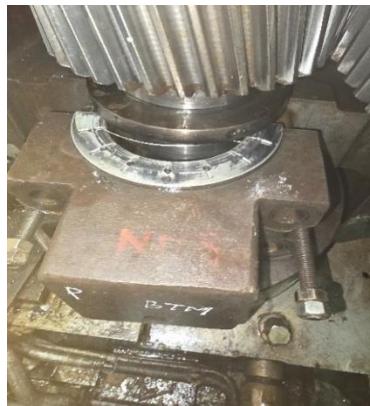
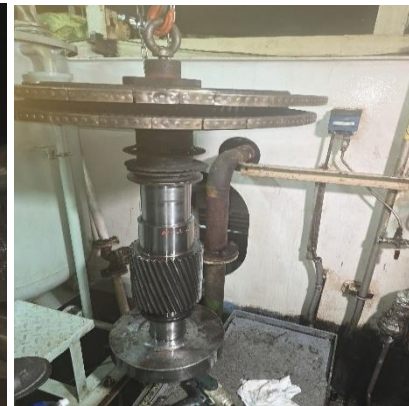
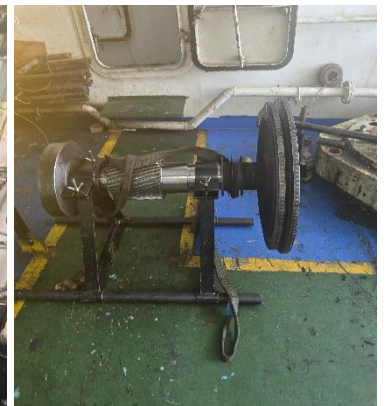
NOTE : (1) TURBINE PINION ROTOR DISC FOUND WITH ONE SECOND ROW BLADE BROKEN OFF & MISSING, & CORRESPONDING SHROUD BAND PORTION BENT OUTWARDS; THIS SHOULD BE THE REASON FOR THE VIBRATION & NOISE DURING PREVIOUS OPERATION.

(2) EXISTING TURBINE PINION ROTOR THRUST COLLAR (1430) FOUND BADLY WORN IN CONJUNCTION.

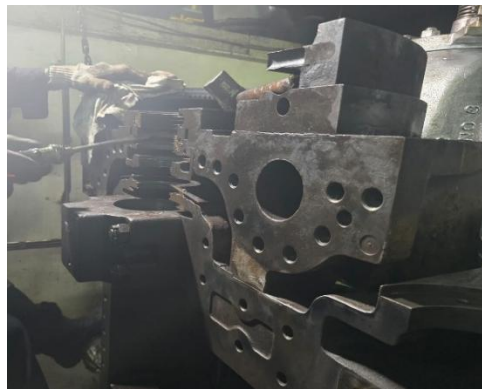
**STEAM CHEST BEFORE CLEANING**

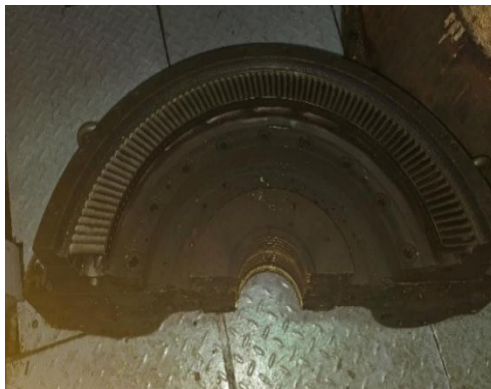
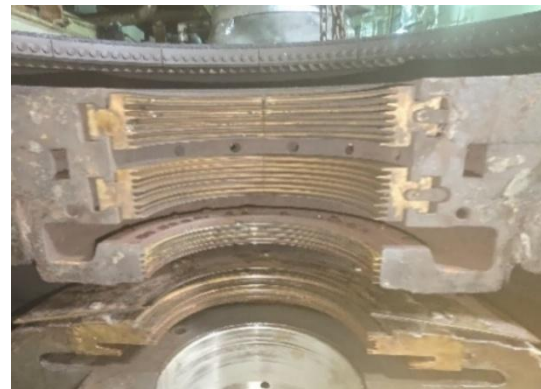
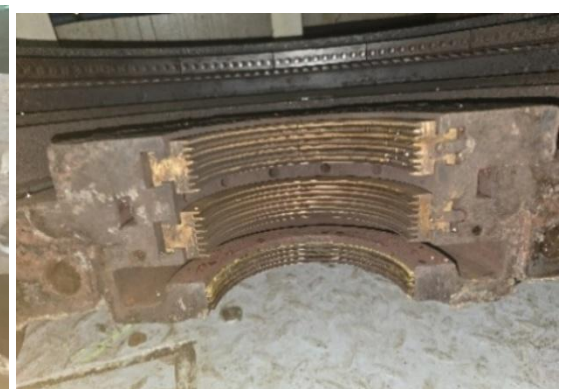
**LABYRINTH PACKING (8 SEGMENTS), STEAM GUARD (1 PAIR) & OIL GUARD (1 PAIR) BEFORE CLEANING**

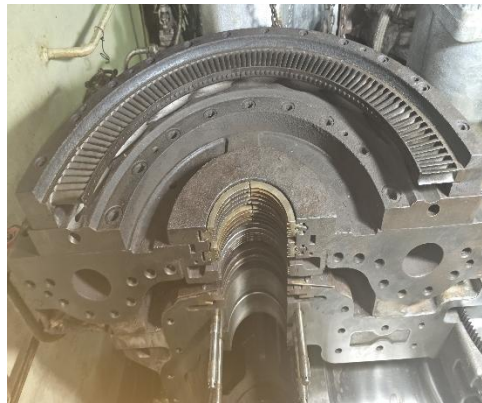
**STEAM CHEST AFTER CLEANING**

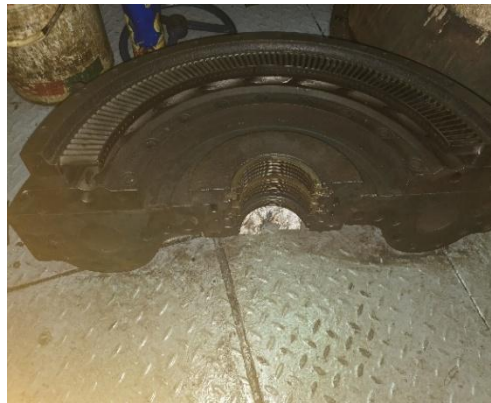
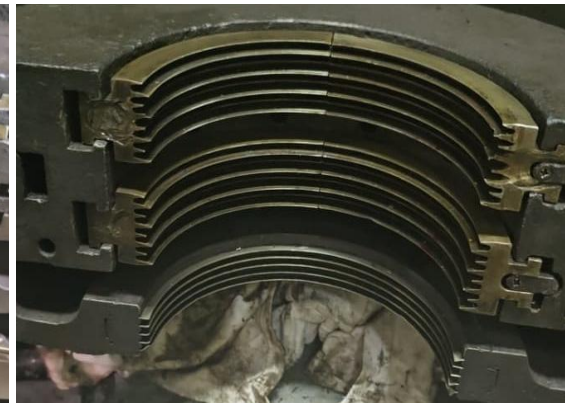
**LABYRINTH PACKING (8 SEGMENTS), STEAM GUARD (1 PAIR) & OIL GUARD (1 PAIR) AFTER CLEANING**

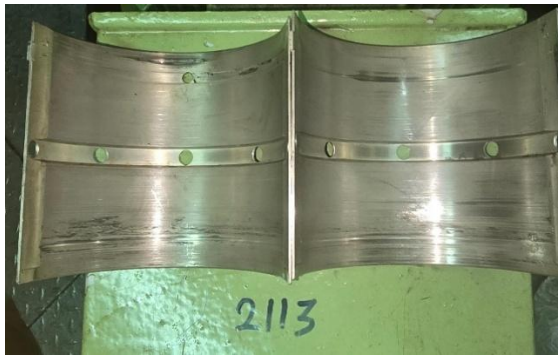
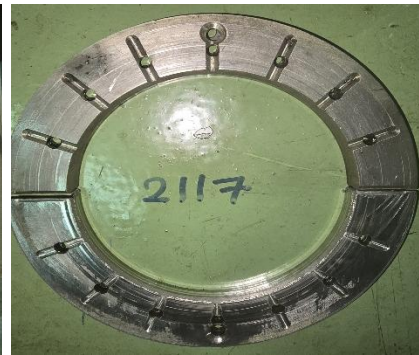
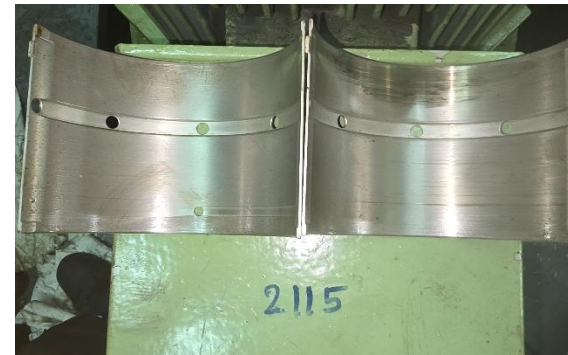
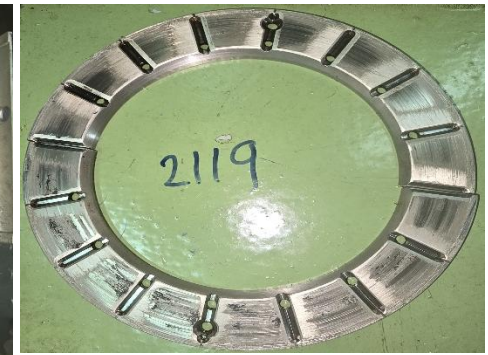
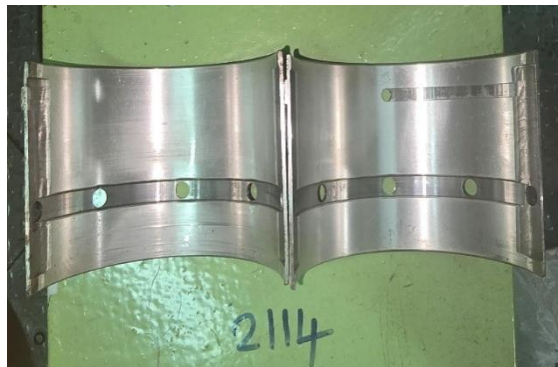
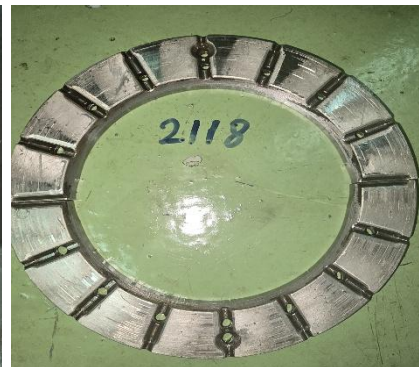
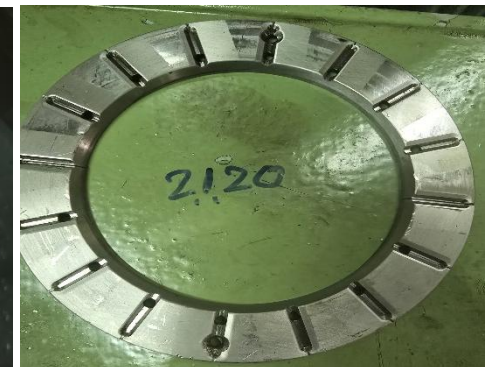
**TURBINE PINION ROTOR BEARING SHELLS & THRUST BEARING METALS****WHEEL GEAR ROTOR BEARING SHELLS & THRUST BEARING METALS**

NOTE : (1) THE EXISTING TURBINE PINION ROTOR THRUST COLLAR (1430) FOUND BADLY WORN & CORRESPONDING UPPER THRUST BEARING METAL (2117) SIMILARLY WORN DOWN; THE THRUST BEARING METALS (2117& 2118) & JOURNAL BEARING SHELLS (2114) WERE REPLACED WITH SHIP'S NEW SPARE ONES; THE REPLACEMENT TURBINE PINION ROTOR CAME WITH A GOOD THRUST COLLAR INCIDENTALLY.

(2) THE EXISTING WHEEL GEAR ROTOR UPPER THRUST BEARING METAL (2119) WAS FOUND WITH WEAR MARKS & SUBSTANTIAL REDUCTION IN RESPECTIVE OIL WEDGE AREAS, & THEREBY WAS DRESSED UP BY POLISHING WOOL FOR REUSE AS SPARE NOT AVAILABLE ON BOARD; THE RENEWAL OF THE THRUST BEARING METAL (2119) RECOMMENDED TO BE EFFECTED AT EARLIEST CONVENIENCE.
